YESTERDAY'S HERO

There is a steadily increasing number of riders who really rate the air-head BMW boxer twins. Why? Duncan Cooper explains this. Part Two: MoT-time, and The Intermittent Fault...

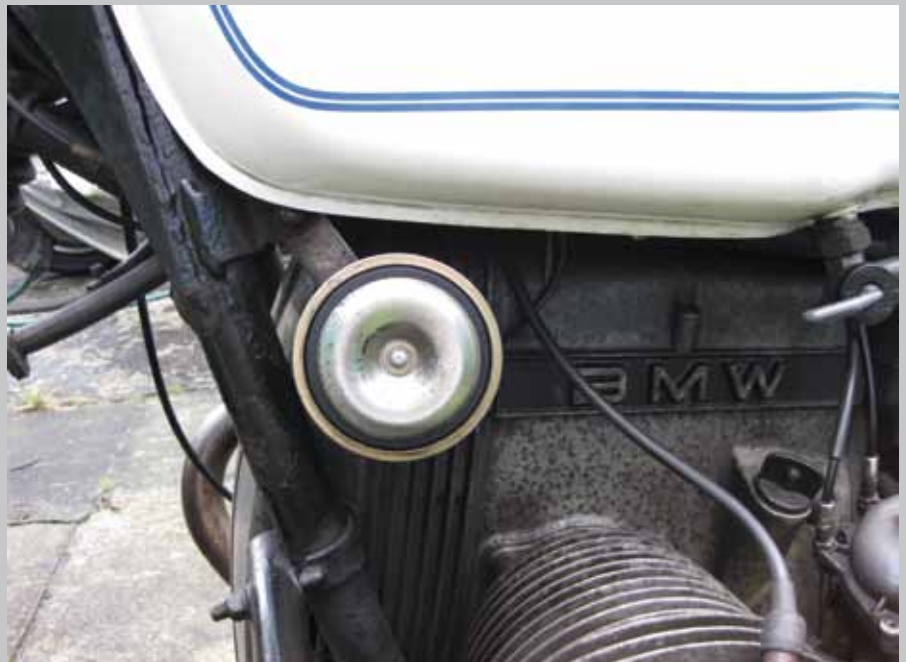
Checking the bike showed that I'd need a working horn before trying for an MoT, so I popped down to the local motor-factor and got this 'universal' one

Before the MoT I thought there were maybe one or two jobs I should do to present the bike in a good light to the tester. The horn didn't work, so I replaced that with a 'universal' item from the local motor-factor. To make a good impression, I decided to clean and paint the subframe which, like the rest of the steel frame, came with a brushed black-over-rust finish. Unbolting the frame and using a wire brush in an angle grinder got the old paint and rust off pretty well, but putting paint back on didn't go quite as well.

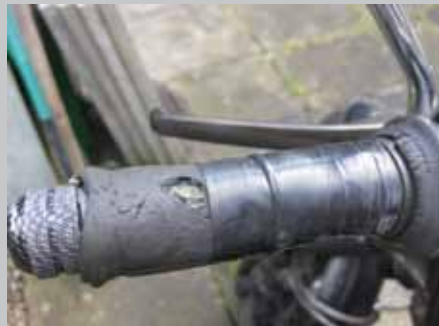
Heated grips had been fitted, but the covering had worn through to the element and they didn't work. For a slightly neater finish I wrapped insulating tape around them, running out before quite finishing the left one

I ran out of Halfords' spray paint and tried finishing the job with spray Smoothrite instead, discovering that these paints react quite badly. Despite this the subframe looked much better, so I decided to move on. To neaten up the wiring I cut out the cables to the non-functioning heated grips and covered the exposed element with insulating tape. I even went the extra mile and glued

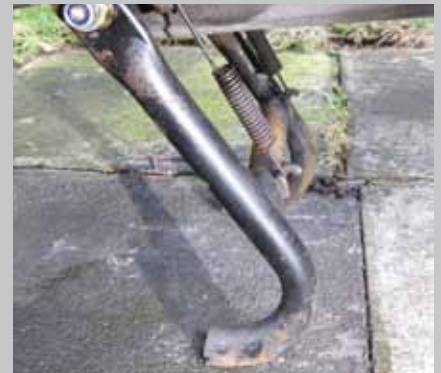
Possibly not an MoT fail, but very disconcerting, was the action of the centrestand, which made the bike lurch alarmingly to the right, away from me, as I heaved it up. The two legs of the stand curve round at the ends, a bit like short skids, so as you pull the bike up and back it rolls smoothly up onto the stand. Or at least that's what Mr Fritz intended. Unfortunately the tube sides which rest on the ground must have rusted away and someone had welded on patches. Rather chunky patches, with the left-hand one standing out more than the right. The tang was also missing.

The curved tubes allow a smooth lift up onto the centrestand. Unless they have rusted through and had chunky patches welded on...

With a loop of wire and a screwdriver used as a 'T' handle, I unhooked the muck-covered springs and removed the bolts through the stand pivots. A process of adding weld and grinding made the heights of the patches more even and smoothed out the step between patches and the original tubing. I even tacked on a new tang. When everything

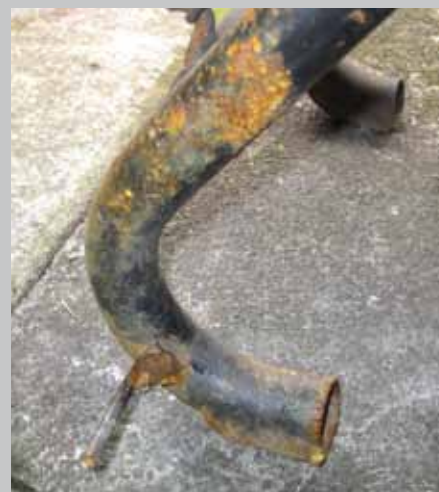
On some types of bike the tang is so strong that you can push down on it as you pull the bike onto its centrestand, but not these BMWs. With these the tang is just to lower the stand, and then you put the ball of your foot on the end of the stand leg to heave the bike up. If you press down on the tang it will probably come off, as seemed to be the case here.

This is the bit of metal rod I welded on as a tang. The picture also demonstrates that one thick coat of paint is not as good as two light ones

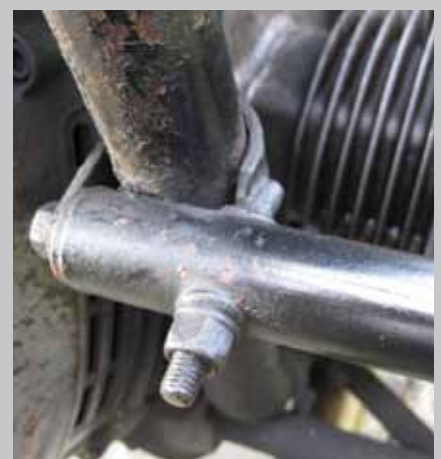
The bolts (or maybe they're studs?) on the right-hand engine bar clamps sheared when I tried to undo them. This clamp's on the left-hand bar and the threads look OK. I'll leave it be for now though!

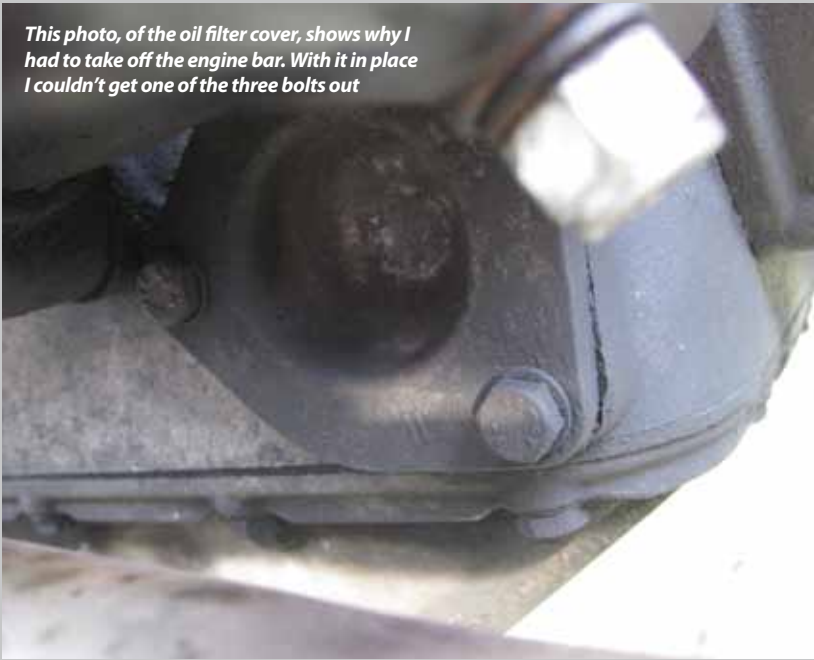
As I intended to ride to the MoT station, I decided that I had to replace the engine and gearbox oils. They were likely to be pretty old, considering the state of the rest of the bike. For this to be a fresh start, I also needed to replace the oil filter, which lives under a cover on the right hand side of the crankcase, very near a frame tube. Now this frame tube isn't a problem, but if engine bars have been fitted, which attach to the frame, the right-hand engine bar stops the cover coming off. This, in itself, should be no problem as there are just two clamps and a large nut holding the bar in place. Regrettably, I seemed to be correct in my assessment of when the oil and filter had last been changed, as the clamp bolts, exposed to the worst of the weather and road grit, had seized solid long ago and sheared as I tried to undo them. On the bright side, I'd got the engine bar off so could replace the oil filter and oils without obstruction. With one engine bar gone I can still carry on...

This photo, of the oil filter cover, shows why I had to take off the engine bar. With it in place I couldn't get one of the three bolts out

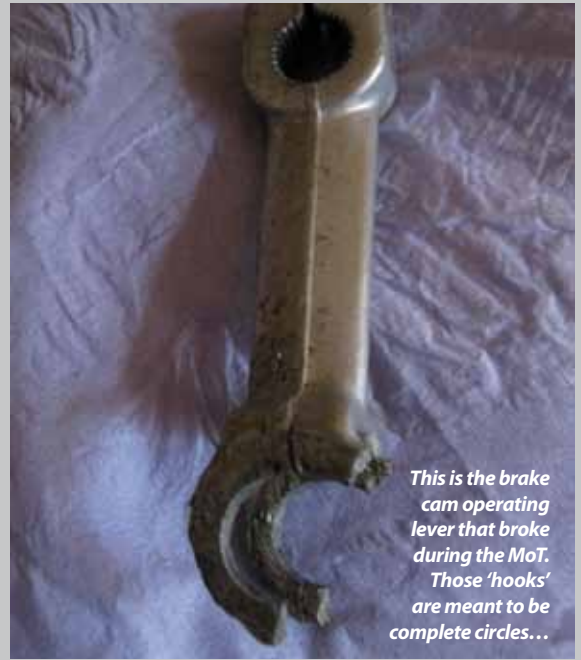
I set off for the testing station, on a wing and a prayer, and the five-ish miles there went fine. I took it pretty easily, as seemed wise, but it was really quite a pleasant ride, with the bike completely changed from when I'd had to fight and coax the thing just to get round a car park. The MoT test itself also went fine until my nerves caught me out when told to apply the rear brake and, unthinkingly, I pressed down with all my not inconsiderable weight. There was a 'ping', the sound of a ricochet and the pedal went limp. The cam operating lever on the rear drum had broken.

The end of this lever is pulled by the operating rod and has the form of two rings, side by side, with a trunnion sitting in these rings. The threaded end of the brake pullrod goes through the trunnion and the winged nut on the end of the rod butts up against the trunnion, so when the rod pulls the lever is moved. What had happened when I bounced on the brake lever was that the front half of each ring had sheared off and disappeared into the depths of the shop. A flashing runs along the centre-line of the alloy lever, creating a potential weak point at the tips of the rings.

From the remains of the lever it looked like corrosion or fatigue had caused twin cracks to form along the flashings, so the force on the cam lever wasn't being contained by two rings, just by two 'hooks'. The excessive force ➤

This is the brake cam operating lever that broke during the MoT. Those 'hooks' are meant to be complete circles...

I'd applied had sheared these off at the base. Not the best thing to happen during an MoT, but better there than on the road. The simple design of the brakes, and an understanding tester, allowed a repair sufficient to pass the brake test and with no other problems the bike got an MoT certificate. Yeh!

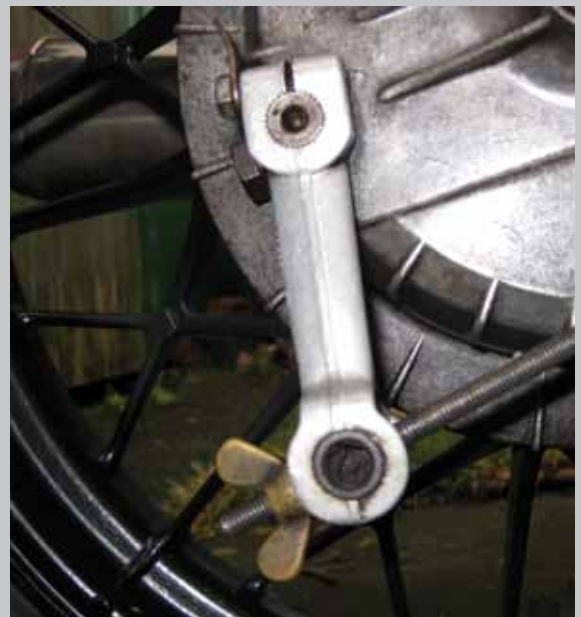
Replacement for the broken cam lever. It's secondhand but shows none of the original's corrosion

I now needed a permanent fix for the back brake, so was soon off to Motorworks, yet again, to check out their selection of secondhand cam levers. The one offered showed none of the marks of age evident on the failed original, even though they must have been made at more or less the same time. Maybe the replacement came from a bike that wasn't run through the winter – many of the bikes on the Motorworks 'Just broken' webpage look better than this R100.

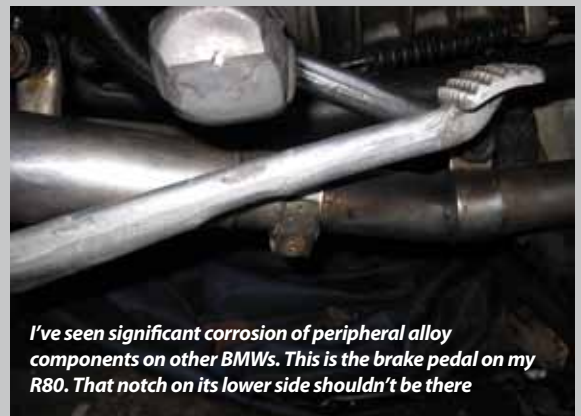
Anyway, it maybe of interest to note that the failing alloy of the original cam lever doesn't seem to be a one-off. I've not undertaken a comprehensive study but I have seen other examples of serious alloy corrosion – a kind of

de-lamination – of certain peripheral alloy components on BMWs of this age and weather-beaten condition. I don't mean the big things like the engine, gearbox, bevel drive or forks, as beneath the weather staining, surface corrosion and scars these all seem sound enough, even on this battered and neglected old R100. But the small components (the brake cam lever, brake pedal, handlebar clamps, gear pedal and the clutch lever at the gearbox) all seem to be made of a different alloy, one more prone to serious corrosion if not kept clean and protected. Of course the cam lever that started me off on this had lasted for thirty years, a service life that could be considered reasonable if we weren't talking about an air-head BMW, a bike built for eternity in most other ways.

I've seen significant corrosion of peripheral alloy components on other BMWs. This is the brake pedal on my R80. That notch on its lower side shouldn't be there

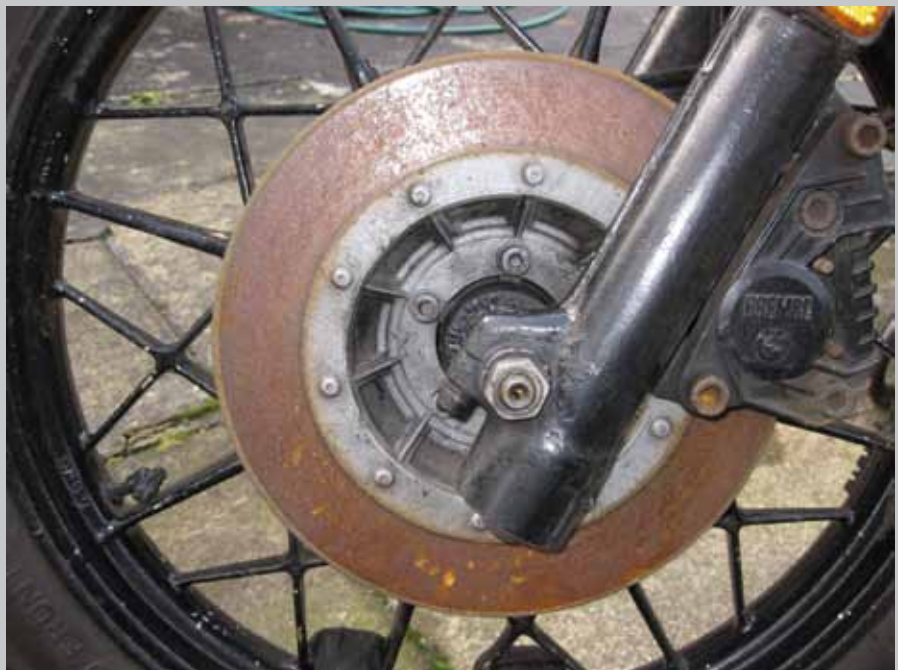
Horrid looking iron disks have been fitted that shed a lot of rust. In case this was somehow causing the brakes to bind I cleaned off the dust round the pistons and pads

I decided to clean up the brake callipers and found that they were indeed covered in orange rust dust, the notches in the pads being packed with the stuff. I bolted the callipers back on and spun the wheel. It spun freely, but it did that before I cleaned the callipers up.

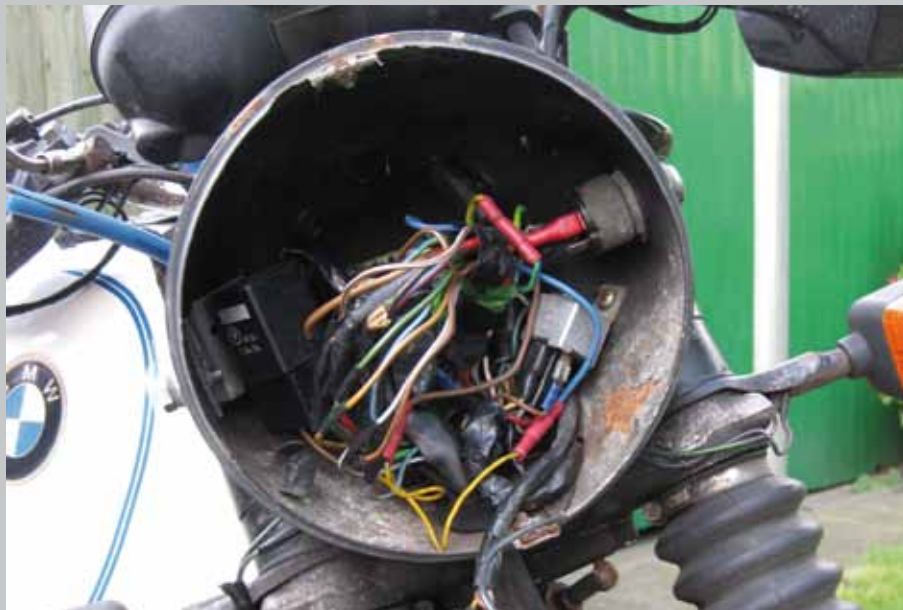
With the headlamp removed, the hacked-about state of the wiring was revealed. It looked like someone had wanted to remove the headlamp and bowl from the machine but hadn't wanted to disconnect the wiring connectors. Instead they'd cut all the wires and then just twisted them back together again to re-connect. Under the loose and slimy insulating tape the twisted strands of copper had oxidised, increasing resistance and explaining the early signs of charring evident.

Groping blindly for an electrical fault, I looked inside the headlamp bowl. It wasn't a pretty sight!

I spent an hour with wire stripper, soldering iron and insulating tape doing worthwhile work, but still not getting any signs of life in return. In despair I sadly searched out my multi-meter and discovered that there was no power to the ignition switch, so the fault must be upstream somewhere. I had to face the fact that I needed to look up the wiring diagram.

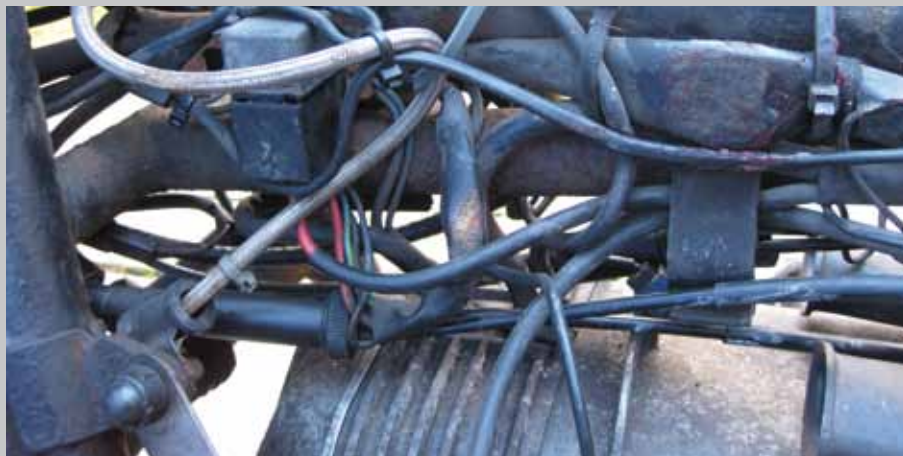
After puzzling over this for a while, I noticed that the power from the battery goes through the starter relay before going on to the ignition switch. I found this relay under the tank and also found that a wire was hanging loose, having corroded through just before the relay spade connector. With a new spade connector crimped onto the end of the wire and pushed onto the relay, the ignition was back on and the bike would run once again. By this time, however, there was no time to go for a ride so the BMW was put away again. The next chance I got, I decided to head for the Peak District using the M60 to nip round

Although the hacked about wiring in the headlamp bowl benefited from some attention, the electrical fault was actually hiding here, under the starter relay
