YESTERDAY'S HERO

There is a steadily increasing number of riders who really rate the air-head BMW boxer twins. Why? Duncan Cooper explains this. Part Two: MoT-time, and The Intermittent Fault...

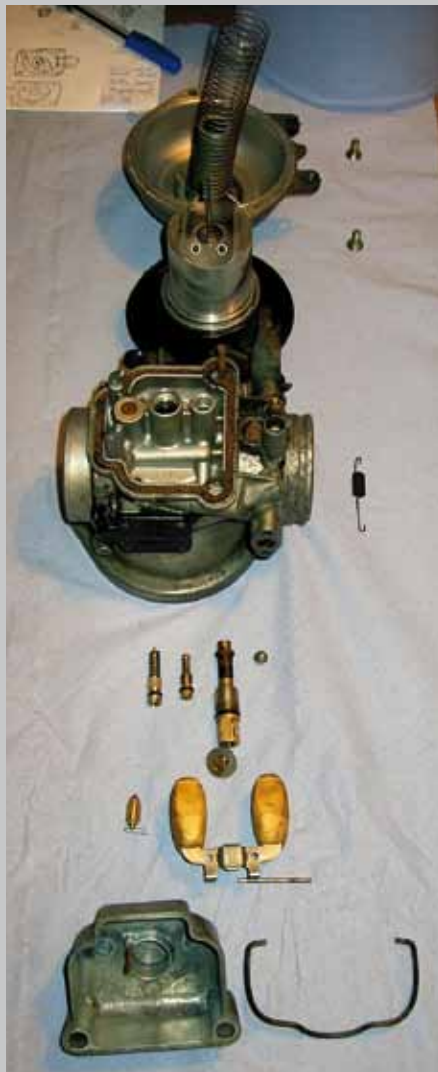
To get to the MoT I needed the bike to run properly. This was largely achieved by rebuilding each carburettor
